U-car Grading Report

CERTIFICATE OF GOO KANTEI

MODEL	PROTON EXORA		
COLOUR	Champagne colour		
MODEL YEAR	-	METERED MILAGE	65,153Km
TYPE		CHASSIS NO.	PL1FZ6YDRCF078308
NOTE	Not flooded

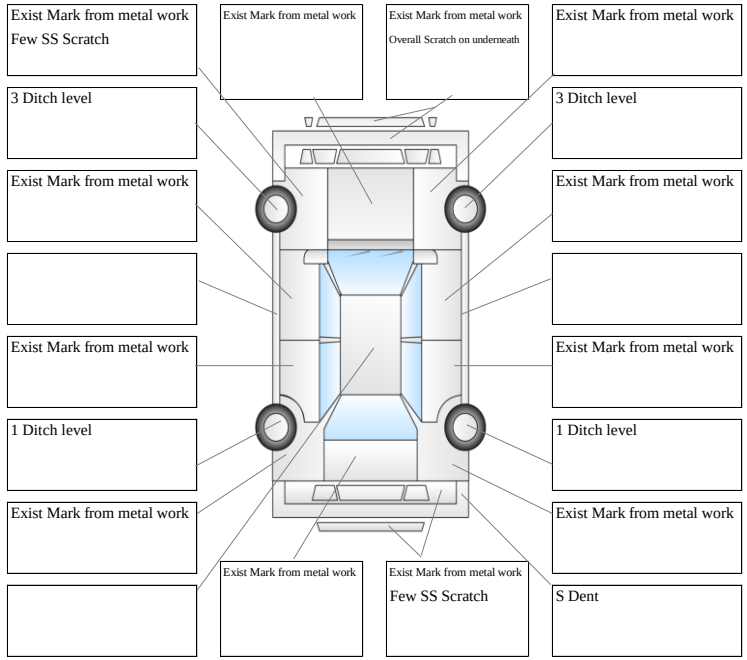
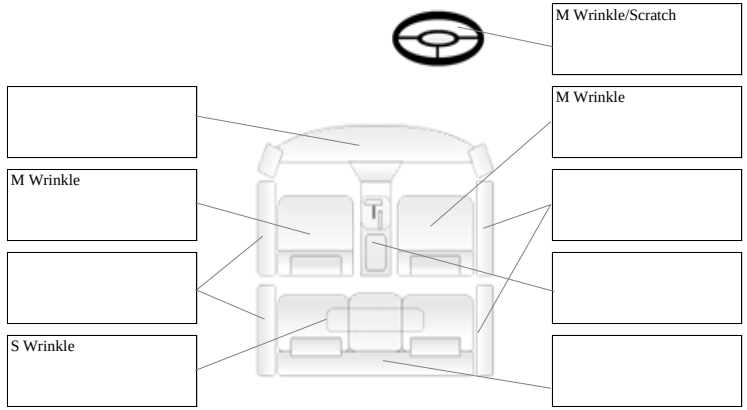
＜Note＞
Entire part of exterior Re-painted
Noticeable Re-painted mark

＜Window＞
Front windscreen Stone chip Partial

＜Interior＞
Luggage room Dirt or Scratch Partial
Shift knob Wrinkle/Scratch Exist
Headliner Wrinkle S
Headliner Dirt S
